Docket No. 217 – Development and Management Plan Inspection

Northeast Utilities Service Company Certificate of Environmental Compatibility and Public Need for the construction of a 345-kV electric transmission line and reconstruction of an existing 115-kV electric transmission line between Connecticut Light and Power Company's Plumtree Substation in Bethel, through the towns of Redding, Weston, and Wilton, and to the Norwalk Substation in Norwalk, Connecticut.

Date: April 12, 2005

Location: 345kV XLPE Component

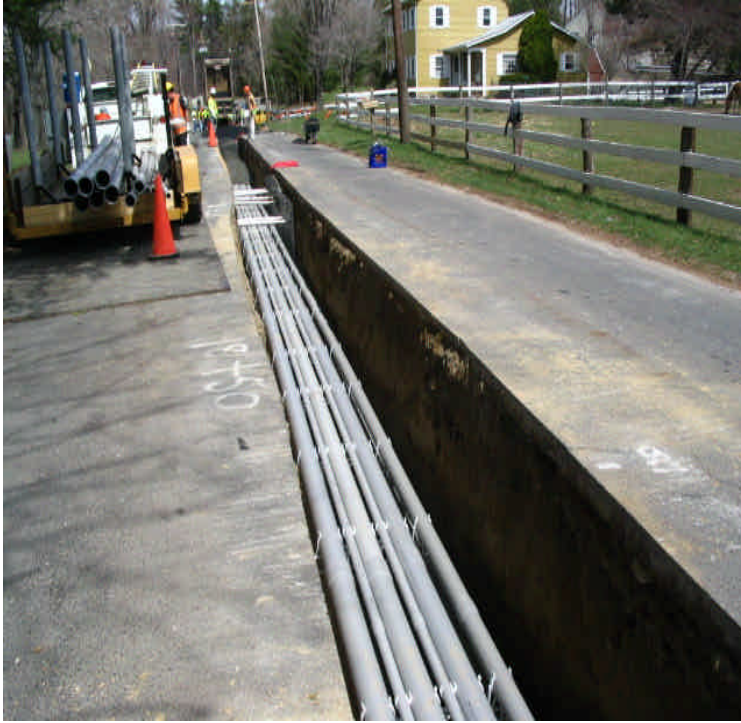
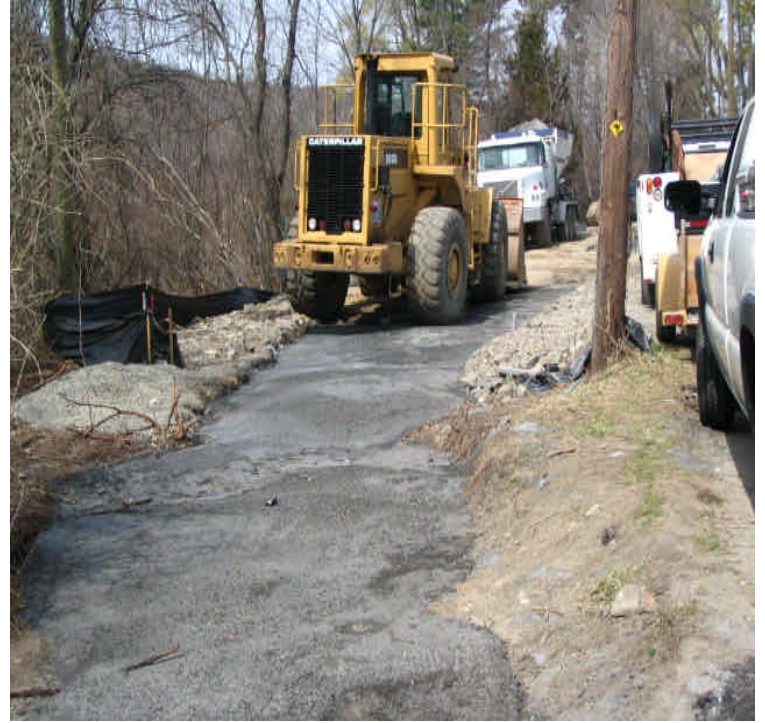
345kV XLPE (Walnut Hill Rd): Photo on the left shows a view of the trenching and installation along Walnut Hill Rd. Photo on the right shows the active trench work in the pull-off near vault 2a and b. 4/12/06

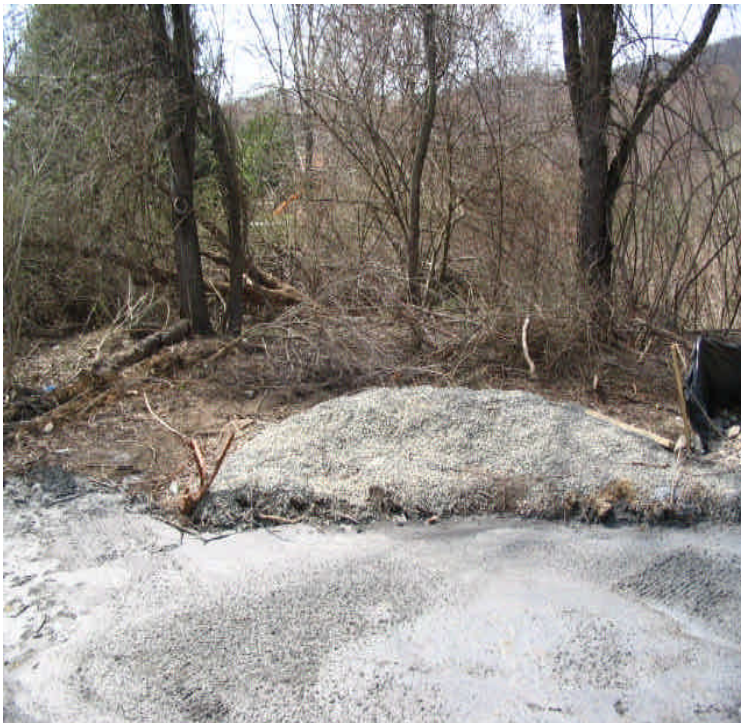
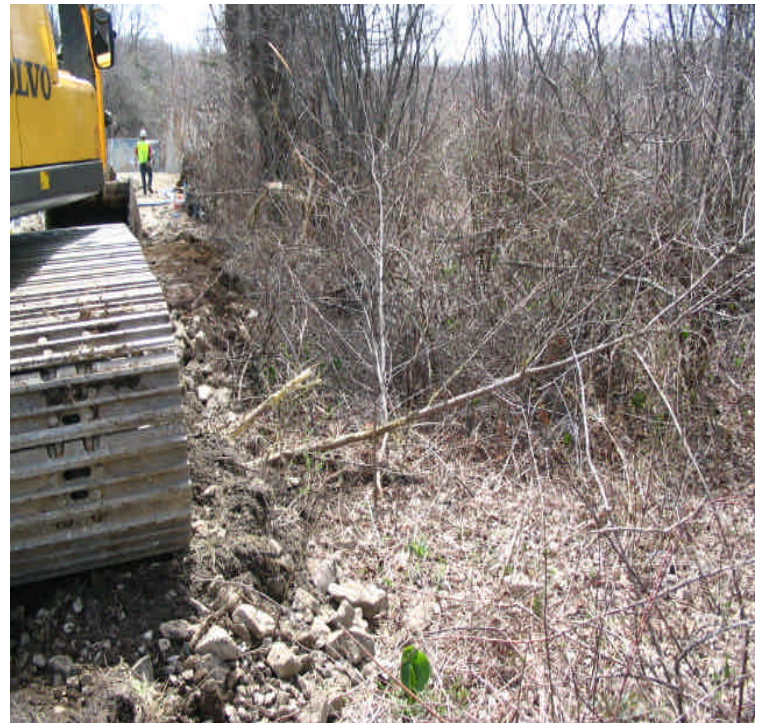
Both photos show either end of the trench work near vault 2 where silt fence should be extended to encompass the disturbed soil here. 4/12/06

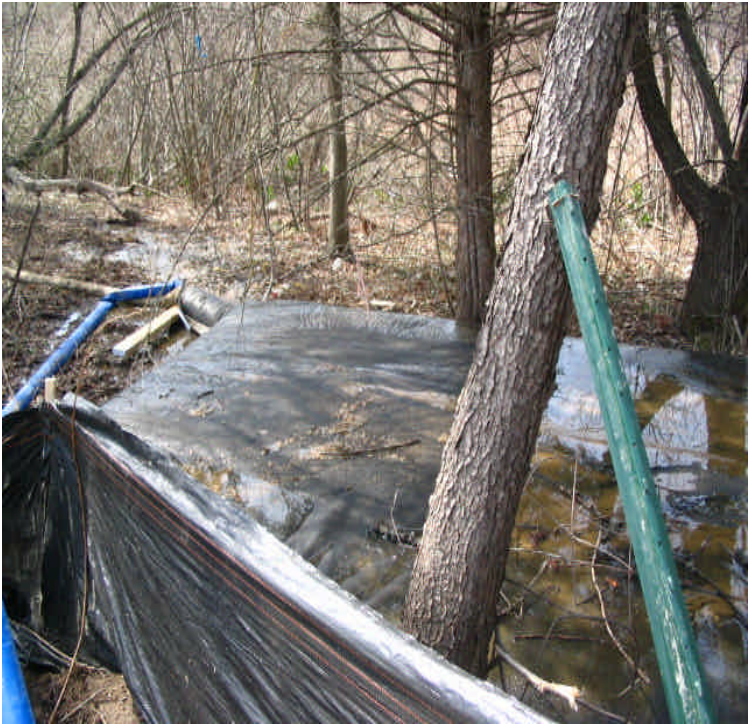
Photo on the left shows the filter bag for dewatering this area. Photo on the right shows the discharge from the bag which is somewhat filtered but could use additional treatment before reaching the wetland. A few haybales or silt fence could be installed. 4/12/06

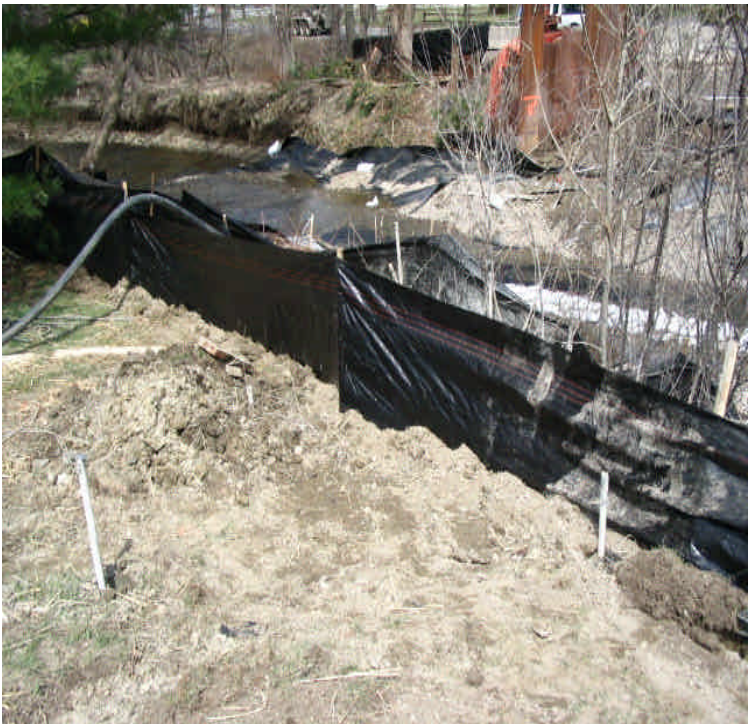
345kV XLPE (Jack and Bore): Photo on the left shows silt fence installed adjacent to recent drill point installations. Photo on the right shows a view of the stream where a diversion is being created with sand bags. Additional stone and lining were added. 4/12/06

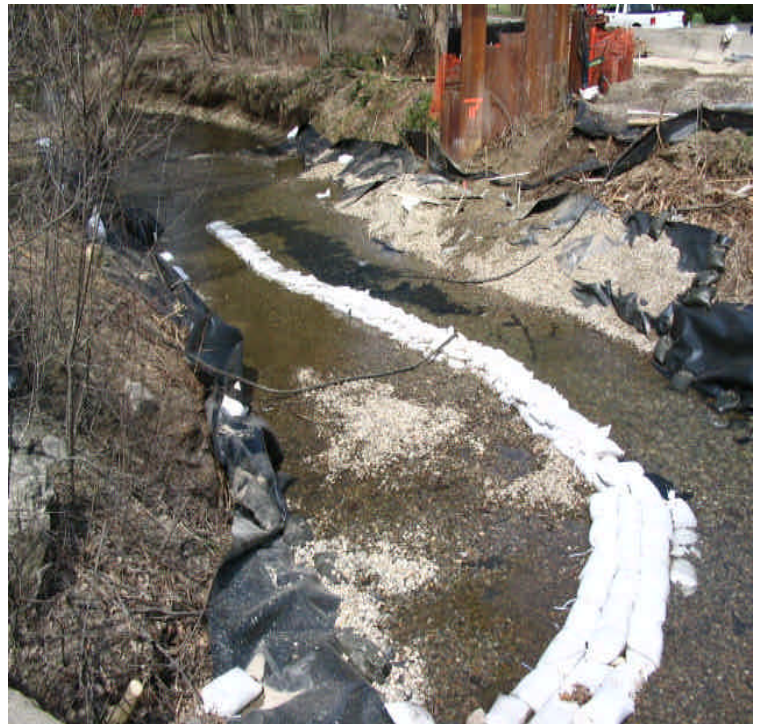
Inland Wetland and Watercourse encroachment and mitigation	-East Swamp Brook crosses under Plumtrees Rd. A large plastic liner is in place across the bed and up along the banks to keep water out of the bore trench. Additional stone was added and sand bags were installed in an attempt to divert the water. 4/6-4/12/06	- The stream continues to run clear. Be sure to remove the liner and restore the natural bed when work is complete. Watch the banks where soil was disturbed for any erosion. 2/16-4/12/06	-N/A at this time until the work is complete
State species of concern, threatened and endangered species	-The D&M plan and clearance letter states that state-listed species are not located in this work area.	- N/A	-N/A

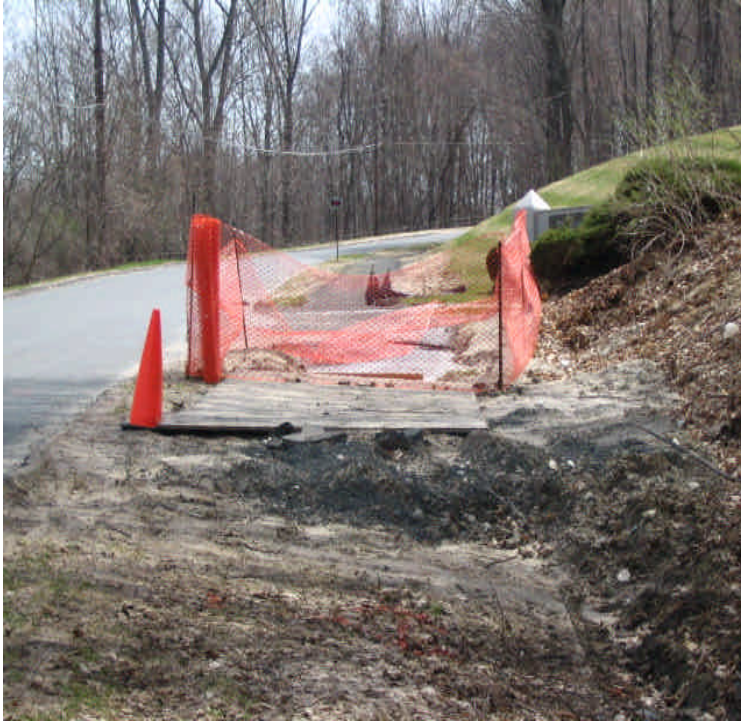
(Whittlesey Dr and Hoyts Hill): Photo on the left shows the end of the trench work on Whittlesey Drive. Photo on the right shows the remaining open excavation near Hoyts Hill at the stone access pad. 4/12/06

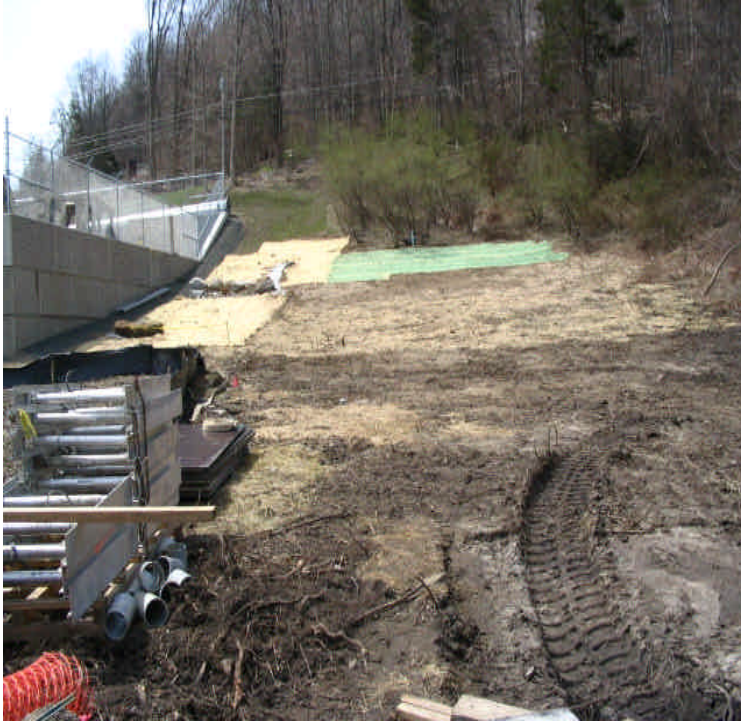
Areas of Inspection	Observation	Recommended Action	Corrective Action
	practicable. 1/19-4/12/06 -Materials were noted stored in the wetland area adjacent to the stone access at Hoyts Hill. Storage in wetlands should be avoided 4/12/06	in use should be covered and stored before leaving for the day. - Continue to keep all vehicles maintained well (i.e. no apparent fluid leaks) if they will be used or stored on site.

Photo on the left shows an overview of the area and the restored slope. Materials were being stored in the adjacent wetland area and vehicles are accessing past the stone. Attempt to avoid this where possible. Photo on the right shows the good controls remaining at the dewatering outlet. 4/12/06
